Correction Model for HS-WIM Systems Based on Pavement Temperature and Vehicle Speed

Gustavo G. Otto - Lucas Franceschi - Bruno M. Gevaerd - Rafael A. Souza - Amir M. Valente
Transportation and Logistics Laboratory (LabTrans)
Federal University of Santa Catarina (UFSC)

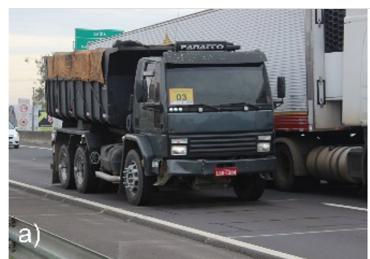
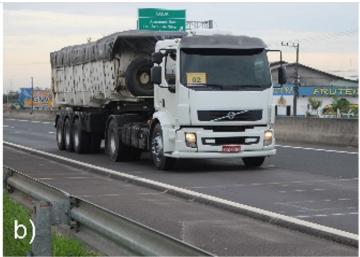
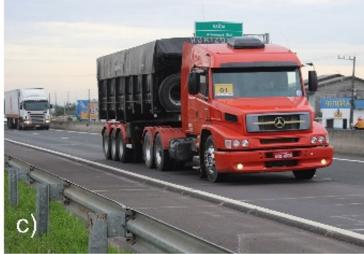
Test campaign using known vehicles

Table 1. Axle weight of each axle of the three reference vehicles

Vehicle	Axle 1 (kN)	Axle 2 (kN)	Axle 3 (kN)	Axle 4 (kN)	Axle 5 (kN)	Axle 6 (kN)
3 axles	53.710	97.048	76.995	_	_	_
5 axles	56.774	102.881	95.054	81.008	67.235	_
6 axles	51.456	90.810	68.190	78.408	81.309	64.286

- ☐ Three types of vehicles.
- Seven (7) runs were planned for each vehicle, for each speed and lateral position.
- ☐ The three speeds chosen are:
 - □ 60, 70 and 80 km/h.
 - ☐ Lateral positioning: left, center and right.
- The test calibration and test evaluations was performed on consecutive days:
 - □ From May 5th to May 8th of 2019 calibration.
 - May 9th of 2019 test for evaluation.
